The Use of COMSOL Multiphysics® Software to Explore Flooding and Rising Dampness Problems Related to Cultural Heritage

H.L. Schellen¹, A.W.M. van Schijndel¹

¹Eindhoven University of Technology, Eindhoven, Netherlands

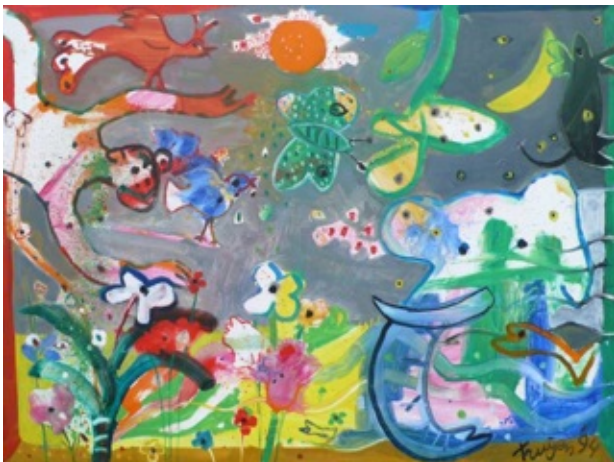
Figure 1: Cobra-like wall paintings by Hans Truijen

Figure 1: Figure 1: Cobra like wall paintings by Hans Truijen.

These paintings in the chapel suffer from an ever faster developing decay. In particular, the lowest parts of the walls and paintings are badly damaged. In some places whole sections of paintings disappeared. Rising dampness in the walls has entrained salts, the drying of these form crystals, which have up to 80 times the volume of salts in the solute state. By varying relative humidities these salts are alternately in solution and crystallize afterwards. This phenomenon expresses the stucco and the already overworked paint of the wall.
