The use of COMSOL to explore flooding and rising water problems related to heritage

Case study St. Catherine's Chapel, Lemiers, The Netherlands

H.L. Schellen*¹, Z. Huijbregts¹, A.W.M. v. Schijndel¹ and R.P. Kramer

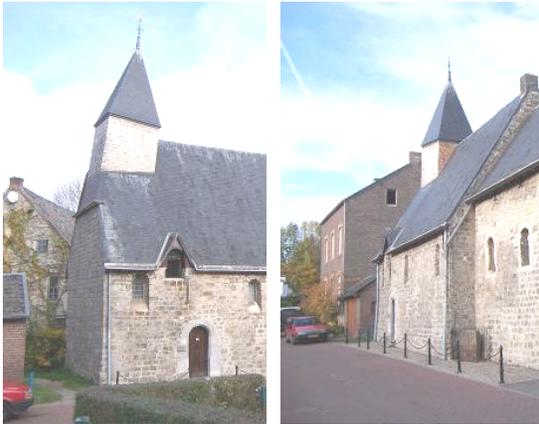
Figure 1. The exterior of the church of Lemiers (Source: nl.wikipedia.org 2012).

As a whole, the building is the only complete surviving example of the earliest type of stone churches known in the Netherlands, a one-aisled building without a tower (Figure 1). Despite its later addition, the rectangular closed choir is typical for these earliest churches as well.

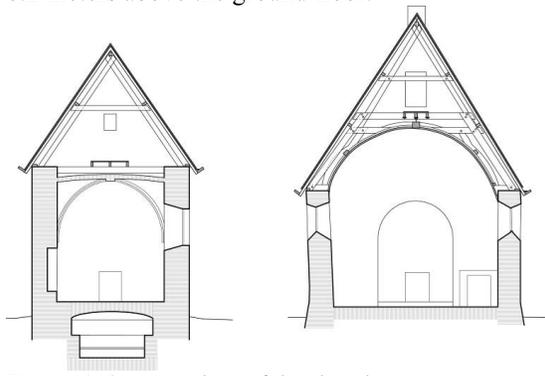
Figure 4. Cross sections of the chapel

The vault of the central nave starts at approximately 4.1 meters above the ground floor and its highest point is located at approximately 6.2 meters above the ground floor.

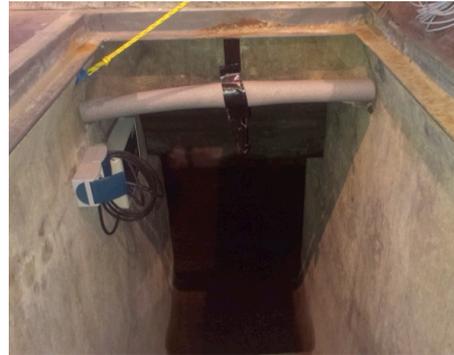
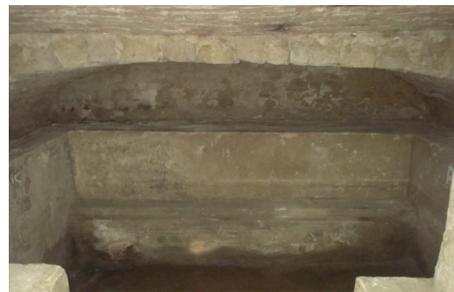
Figure 5. Entrance of the wet crypt (up) with a few centimetres of standing water (down)

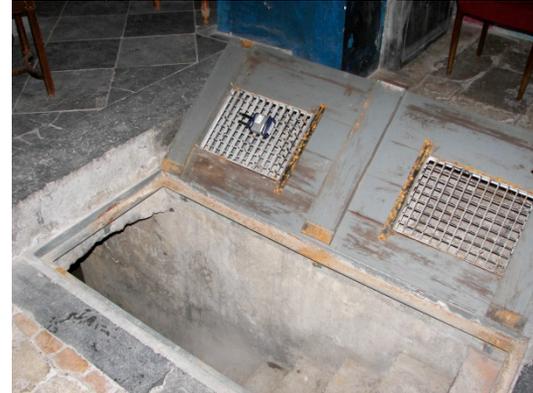
Figure 13. Crypt entrance: measurement equipment is placed on the screen of the hatch between chapel (nave) and crypt

Besides, the measuring equipment in the crypt is placed on the screen of the crypts access hatch (figure 12). This means that the crypt is in open connection with the chapel. Therefore the measured data of the crypt can be influenced by the chapel, but to what extent is not further considered.
